# Influence of soil microorganisms on metal corrosion of underground pipelines

Polutrenko M.<sup>1</sup>, Maruschak P.<sup>2</sup>, Tymoshenko A.<sup>3</sup>, Sorochak A.<sup>2</sup>

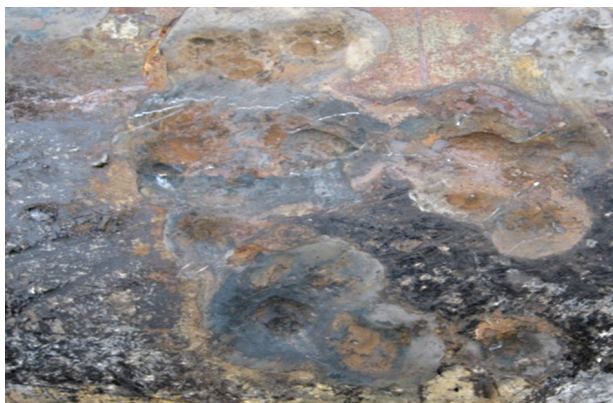
On the outer surface of the gas main "Pasichna – Tysmenytsia" (Fig. 1), multiple corrosive ulcers caused by the influence of biocorrosion are shown. Such defects are typical damage to the metal due to the formation of local sulfide deposits and microorganism colonies in the ground electrolyte in the presence of hydrogen sulfide of biogenic origin on the surface [6, 9]. The unevenness of the surface damage should be noted, which confirms the localization of corrosion processes. This suggests that even small fluctuations in microbiocenosis affect the kinetics of damage to the metalwork.

Fig. 1. Corrosion ulcers found on the wall of the gas main "Pasichna – Tysmenytsia"

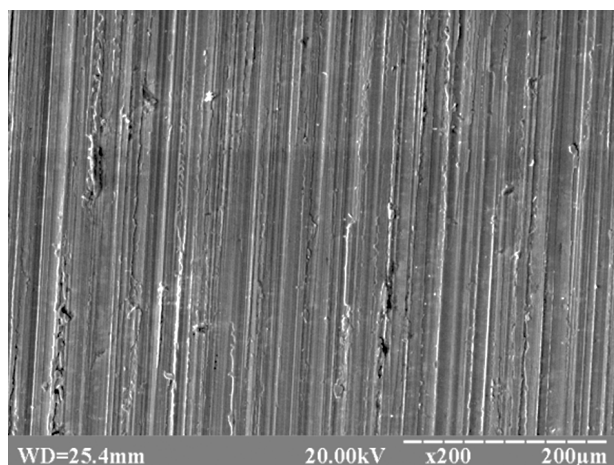
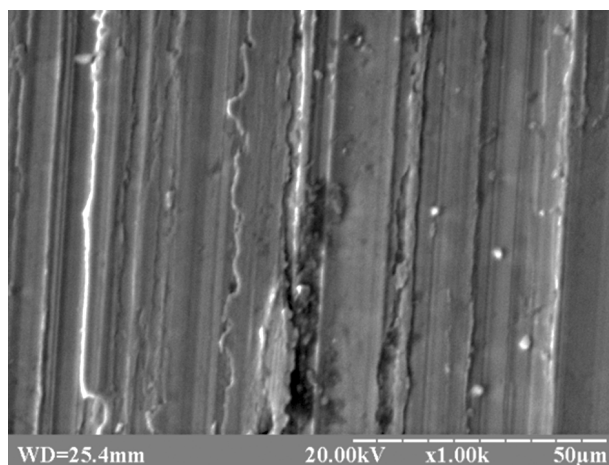
Fig. 2. Surface morphology of steel 17G1S-U at various magnifications in the initial state

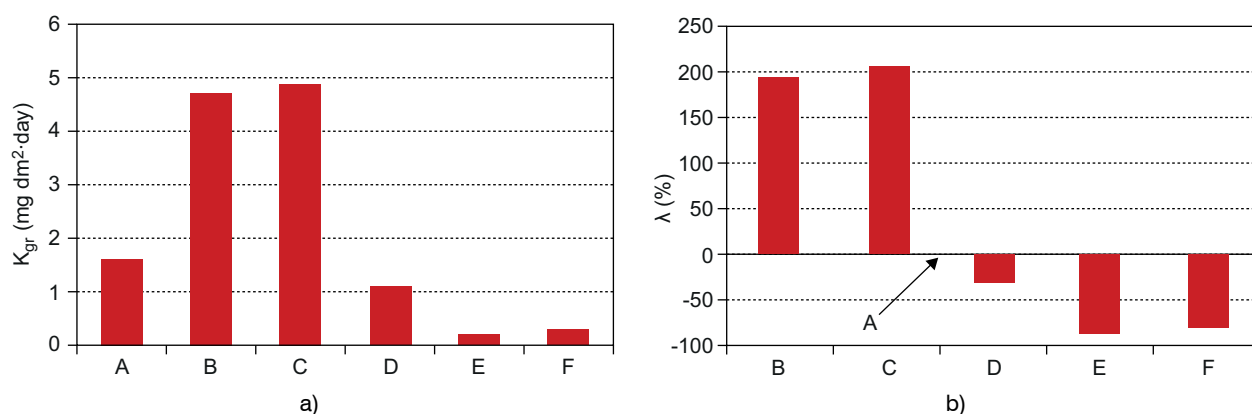
An increase in the corrosion rate in the case of test schemes B, C was found, indicating their significant biocorrosion activity:  $\lambda_B = 193.75\%$  and  $\lambda_C = 206.25\%$ . For the test schemes D, E, F, a decrease in the corrosion rate was observed:  $\lambda_D = 31.25\%$ ,  $\lambda_E = 87.50\%$ , and  $\lambda_F = 81.25\%$ , respectively. The sign “-“ in this case indicates that the biocorrosion rate of the steel 17G1S-U in these media was lower than in the control A medium.

Fig. 3. Corrosion rate of specimens from steel 17G1S-U in the presence of *Desulfovibrio sp.* strains Kyiv-10 in the following media: A – control A medium; B – Postgate's B medium + SRB; C – Postgate's B medium + SRB + inhibitor # 1–0.5%; D – Postgate's B medium + SRB + inhibitor # 1–1.0%; E – Postgate's B medium + SRB + inhibitor # 2–0.5%; F – Postgate's B medium + SRB + inhibitor # 2–1.0%

The analysis of findings of the experimental research into the growth suppression of SRB bacteria *Desulfovibrio sp.* strains Kyiv-10 in the course of model laboratory experiments showed that in the sterile Postgate's B medium, in the case of steel 17G1S-U, no corrosion traces were detected. The relative corrosion activity, Fig. 3b, was calculated by the formula:

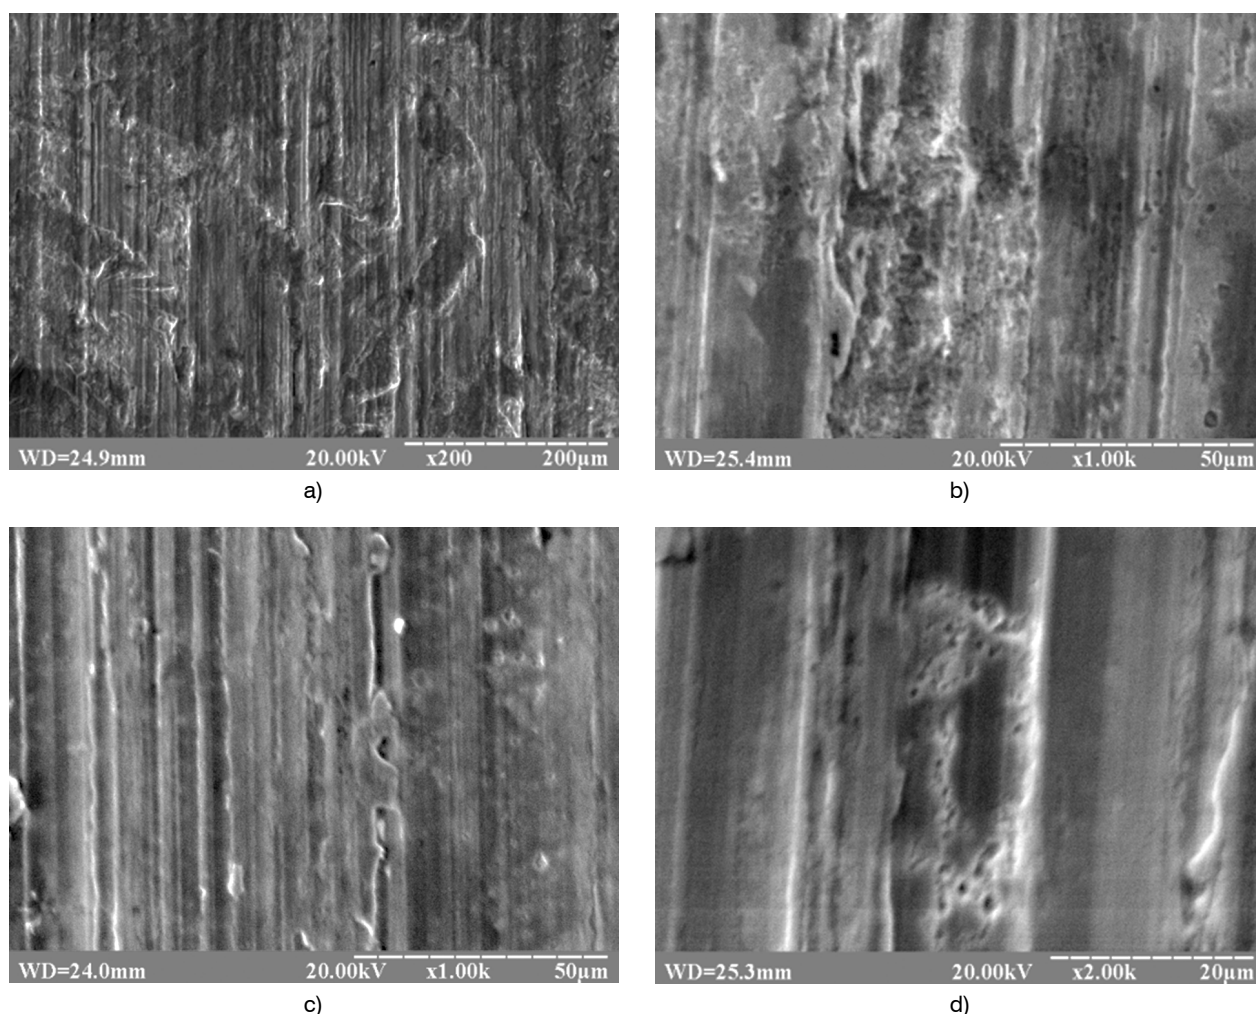
As noted above, inhibitor # 1 intensified the corrosion process (test scheme C). On the surface of the specimens, Fig. 4a,b, "islets" with a length of 40-100  $\mu\text{m}$  and a width of 50  $\mu\text{m}$  were found.

They have a random orientation that intersects the initial deformation relief at various angles. These islets have no clearly defined orientation and are merged into the network. The depressions between the islands were the sites of macrolocation of the corrosion process. Despite such "islet", corrosion developed quite uniformly in the depressions. According to the test scheme (D), uniform corrosion damage was detected on the specimen surface along with several macro-ulcers with a length up to 100  $\mu\text{m}$  and a width 20-30  $\mu\text{m}$ . Visually their depth varies slightly, the bottom is practically flat and covered with traces of corrosion, Fig. 4b.

Fig. 4. Morphology of the surface of specimens from steel 17G1S-U subjected to the effect of biocorrosion in different media: a) Postgate's B medium + SRB + inhibitor # 1–0.5%; b) Postgate's B medium + SRB + inhibitor # 1–1.0%; c) Postgate's B medium + SRB + inhibitor # 2–0.5%; d) Postgate's B medium + SRB + inhibitor # 2–1.0%

The maximum inhibitory effect with suppressing the growth of SRB on specimens from the 17G1S-U steel was caused by inhibitor # 2. Even when added at a concentration of 0.5% (test scheme E), this inhibitor caused a reduction in corrosion, the specimen surface had only minor corrosion damage. The deformation relief of the analyzed surface, due to mechanical treatment, remained virtually in its original state, Fig. 4c.

According to the test scheme (F), the corrosion resistance of the 17G1S-U steel was insignificant. The surface is virtually in its initial state with individual microcorrosion damages, which manifested itself only in large increments, Fig. 4c. The results of the conducted studies indicate that an effective inhibitor of microbial corrosion of steel under the influence of SRB was inhibitor # 2. The high protective effect of inhibitor # 2, which is associated with quaternary ammonium salts, is probably due to the fact that, under microbial corrosion, a thin sulfide film is formed that is coated with a monomolecular layer of the inhibitor, which stops its further growth and inhibits the anodic dissolution of the metal [14 -15].
