# PRODUCTION ENGINEERING ARCHIVES

## Influence of the environment aggressiveness on durability of girders made of S355 steel in Poland

The following article discusses the problem of durability of girders made of structural steel S355 affected by corrosion. It presents the Polish procedure for calculating the time between failures of steel elements of bridge and durability factors necessary to estimate the impact of corrosion on the durability of steel road bridges. According to the presented procedure, two real bridges of steel structure were analysed. The bridges selected for analysis are located in extremely different corrosive environments in Poland. This bridges were built in different areas of the country which are characterized by different (mountain, urban) aggressiveness of the environment. The objects of the analysis differ in terms of corrosion type occurring on the bearing system. Their age is also different which has a significant impact on their safety. The results obtained allowed to determine the time when, with the existing corrosion damage, failures may occur.

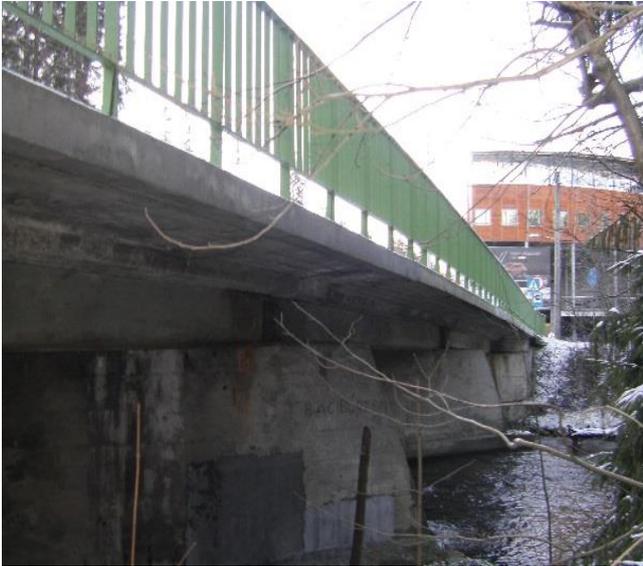
Fig 2. The analyzed bridges -stream Malinka in Wisla

For the analysis a bridge in Wisla (Fig. 1), which is part of the inter-regional road 942, and the bridge, which is part of the inter-district road 1661D in Wroclaw (Fig. 2), were chosen. The analysis was carried out based on the data from

BRIDGE IN WISLA – Silesian province			
Type of barrier		stream Malinka	
Road number	942	Placement	km 36+566
Durability reduction coefficient			
$S_A$	$K_R$	$\beta$	$W$
0.98	0.923	0.96	54
$T_w$	$T_i$	$T_D$	
0.98	0.90	-	
Level of shortening the time between failures of structures			$S_T$ 0.850
Time between failures of structure due to corrosion			$T_e$ 27

The bridge in Wisla is part of the road from Wisla to Szczyrk through the mountain pass, Samopolska, characterized by a large slope and a dozen sharp curves. In winter, for safety reasons, this road must be perfectly maintained. The technical conditions of the elements of the analyzed bridges are alarming or insufficient, in most cases, the evaluation of the technical conditions of all objects is 2-3. The scale of assessment of the technical condition of individual elements of the bridges has 6 states, where 0 is the state of emergency, 1 is the state before emergency, 2 is the state of insufficiency, 3 is the state of alert, 4 is the state of sufficiency, 5 is the state of appropriateness. Very often, after screening, it is concluded that the existing damage can pose a threat to public safety or may limit the utility of the bridge structure. Therefore, the maintenance and renovation of objects and their corrosion protection are very important, as they allow an extension of a period of time between their failures.

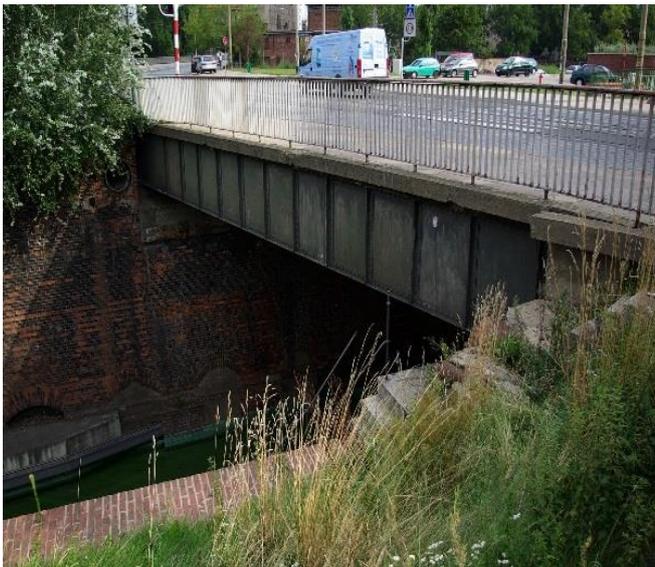
Fig 2. The analyzed bridges -lock in the city in Wrocław

BRIDGE IN WROCŁAW – Lower Silesian province			
Type of barrier		lock in the city	
Road number	1661D	Placement	Sienkiewicza Street
Durability reduction coefficient			
$S_A$	$K_R$	$\beta$	$W$
0.98	0.891	0.99	81
$T_w$	$T_i$	$T_D$	
0.99	0.96	0.96	
Level of shortening the time between failures of structures			$S_T$ 0.847
Time between failures of structure due to corrosion			$T_e$ 3
