## The evaluation of wear of tungsten carbide dental bur

Due to its durability, tungsten carbide has long been used as a material to produce dental burs. WC-Co burs are designed for smooth, efficient cutting and extended life. Dental burs are available in different sizes and shapes, for example round burs, pear and cylinder-shaped, egg-shaped, as well as there are various tapered ones, which enable an individual selection of the drill for the right treatment. Carbides can be used for standard crowns and bridges, for extensive surgical procedures and they should minimize damage to the existing teeth. The design of WC-Co dental bur reduces a patient's discomfort because of the operating time and the fact that its liquidity is preserved. The head of the bur (the cutting edge) delivers optimum concentricity and strength. The shank is made from stainless steel allowing a bur to be autoclaved multiple times without the risk of corrosion. The main purpose of this study was to evaluate the wear of a tungsten carbide dental bur. The results of stereoscopy microscope and SEM/EDS analysis are presented.

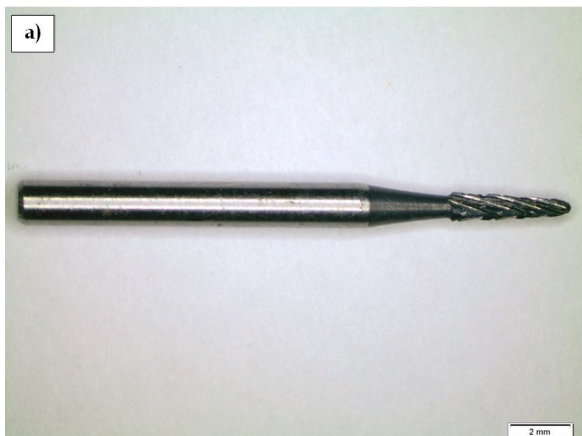
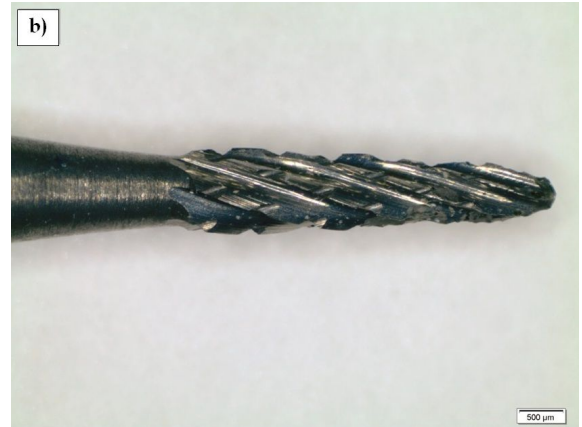
**Fig. 1.** Tungsten carbide dental bur after use: a) all shape, b) bur head (the cutting edge)

The macroscopic image of the surface of the tungsten carbide dental bur obtained from a stereo microscope Olympus SZ61 is presented in Figure 1. Figure 1b presents the working part of the long round end tapered shape bur, on which edge abrasion and crumbling away of surface were observed.

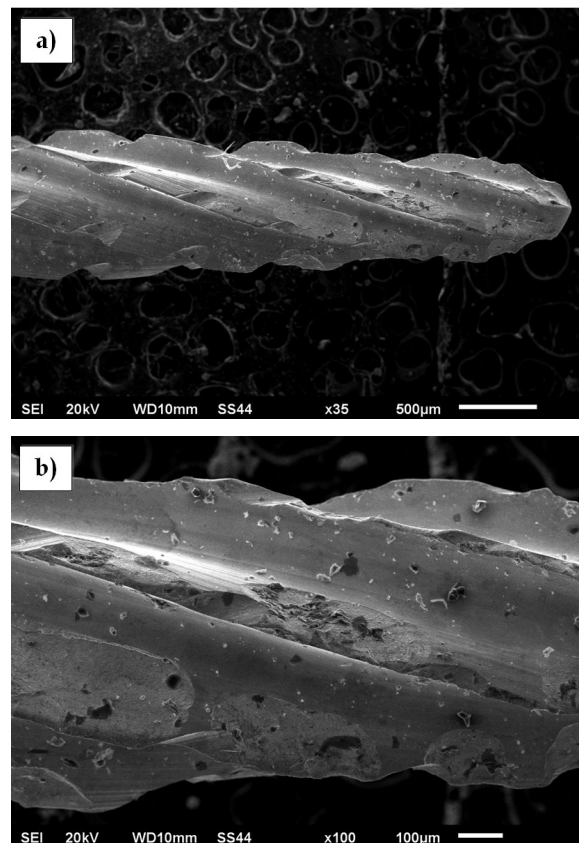
**Fig 2.** WC-Co dental bur after use: bur head (the cutting edge)

SEM analysis was carried out to observe the surface of the tungsten carbide dental bur by scanning with a microscope Jeol JSM-6610LV. After three months' use, traces of wear were observed on the tested bur. Figure 2 presents the surface of the wear on the head of the bur (the cutting edge). Figure 3 presents the surface of round end taper of the head of the bur.

Tungsten carbide burs are designed to cut more effectively and reduce the risk of chipping or breakage. The working part of the long round end tapered bur was degraded as a result of abrasion. Defects in the form of cracks, crumbling and

microcracks were observed on the surface of the tungsten carbide bur. Moreover, depositing of tooth enamel dust on the working part was also observed.

The obtained results show that corrosion was nearly unnoticeable. It was observed that the surface of the working of the WC-Co dental bur part degraded. The degradation of the working part of WC-Co dental bur occurred in the form of abrasion round end taper of bur head, crumbling and surface delamination.

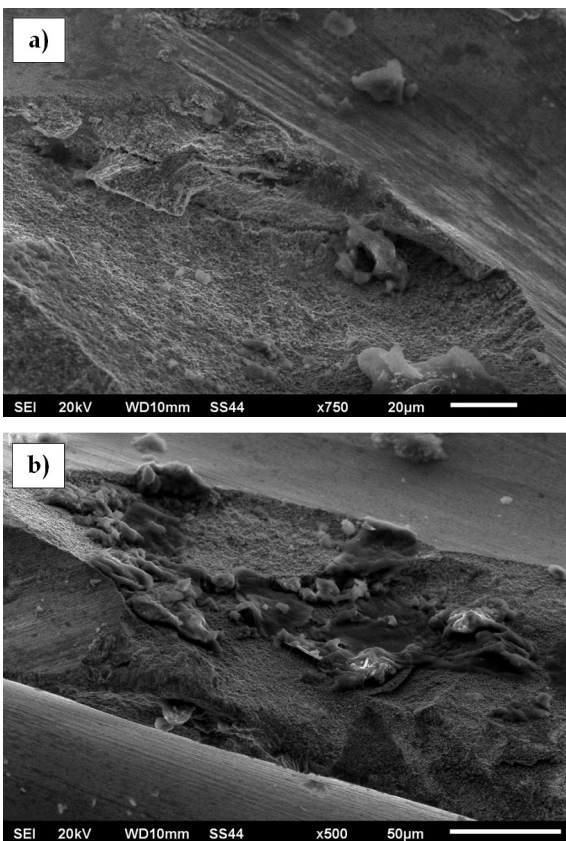
**Fig 4.** The losses of the surface of WC-Co dental bur

Figure 4 shows the losses of the surface of dental bur after three months' use.

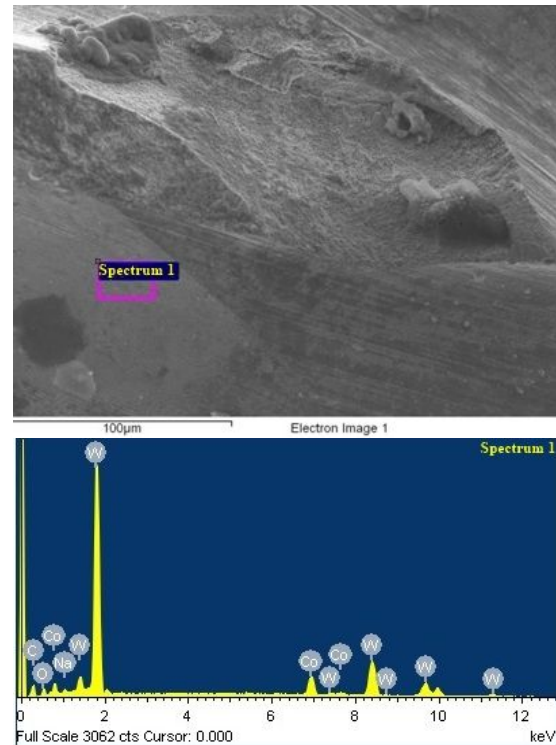
**Fig 5.** The analysis of chemical composition of surface of WC-Co bur (Spectrum 1) without damage

Figure 5 shows the analysis of chemical composition of the surface of WC-Co bur without damage. The results of EDX-analysis of chemical composition is presented in Table 1. The analysis of chemical composition of the surface WC-Co revealed the content of elements from which the working part of the bur was built.

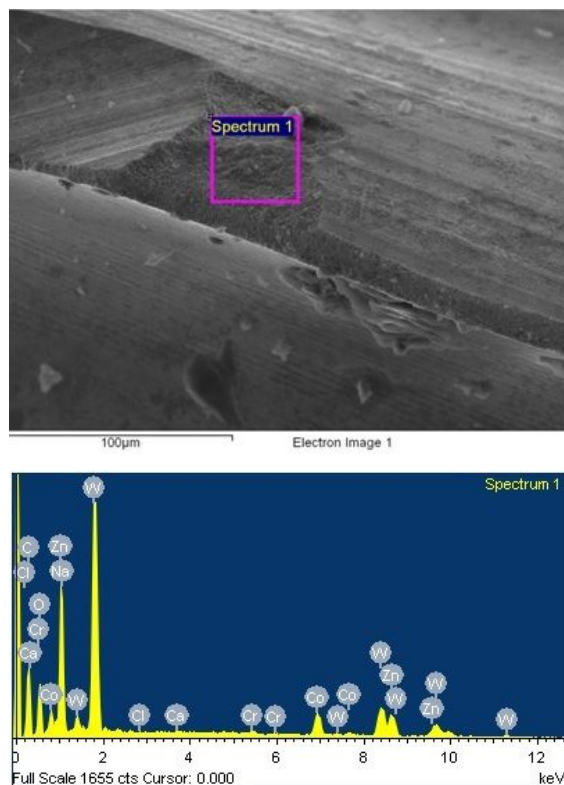
Fig 6. The analysis of chemical composition of surface of WC-Co bur (Spectrum 1) with damage

Figure 6 presents the analysis of chemical composition of the surface of WC-Co bur with damage. The results of EDX-analysis of chemical composition are presented in Table 2.

The analysis of chemical composition of the surface WC-Co revealed elements from damage caused by the use of the bur. The elements are from tooth tissues during use of burs and their sterilization.

To reduce the wear of the WC-Co bur slightly, it should be used as intended. In addition, sterilization processes should be controlled, which also affects the damage in the bur.
