LASER DOPPLER VIBROMETER BASED EXAMINATION OF THE EFFICIENCY OF INTRODUCING ARTIFICIAL DELAMINATIONS INTO COMPOSITE SHELLS

Kamila Kustron, Ph. D.

Institute of Aeronautics and Applied Mechanics, Poland

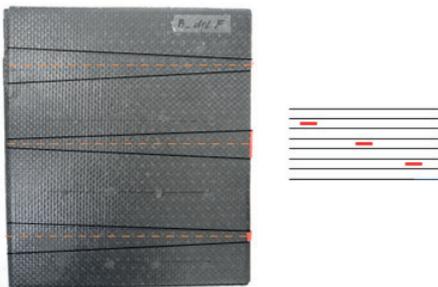
Fig. 1. A5 specimen made of carbon-epoxy laminate with local separation layers alternately introduced to obtain delaminations having the assumed areas and the shapes of isosceles trapeziums with bases of 5 and 20 mm

The article reports results of tests oriented on evaluating the delamination area and position depth in specimens with delaminations artificially generated between the composite layers. The specimens, prepared from glass- and carbon-epoxy laminates, had the A5 size. The generated artificial delaminations had the form of non-adhesive areas created between the laminate layers during the composite production process. These areas were created using three methods, by introducing: (1) a thin polyethylene film, (2) a teflon insert, and (3) a thin layer of polyvinyl alcohol. The delamination areas had the shapes of isosceles trapeziums with bases of 5 and 20 mm in length, arranged in such a way that the longer base is situated alternately at the left and right side of the specimen (Fig. 1a).

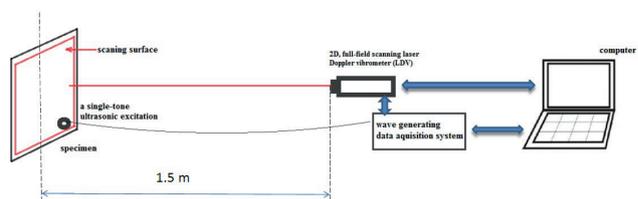
Fig. 2. Scheme of the test rig used for evaluation of the area of artificial delamination in the laminate structure

The examined specimen was mounted vertically at the distance of 1,5 m from the laser Doppler vibrometer. A high-frequency piezo activator which generates constant-frequency waves was wax-glued on the specimen. The assumed vibration frequency was equal to 80 kHz, following expert recommendations by Erick Flynn of Los Alamos National Laboratory. During the test, Lambda waves were generated in the specimen and, simultaneously, the surface of the specimen was scanned using the 2D Doppler laser. The visualisation was obtained via automatic estimation based on the assessment of the wave number, pixel-by-pixel, being the response to the excitation in the wave number domain [7]. The advantage of the applied method is that it does not need reference patterns. Anomalies in the image indicate the presence of deformations, which are larger in places with delaminations due to lower stiffness of these areas caused by the loss of interlayer integrity.

The tests were performed in the Engineering Institute, Los Alamos National Laboratory, USA, using the measuring set schematically shown in Fig. 2.

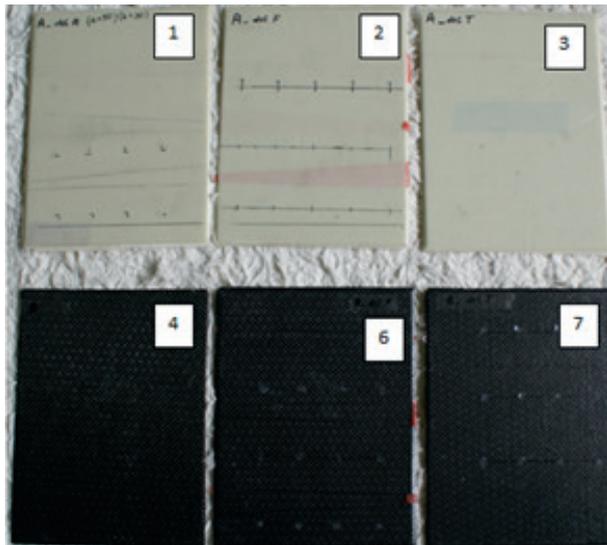
Fig. 3. Photo of the set of specimens used in the examination performed with the aid of the laser Doppler vibrometer to assess the areas of delamination

Specimens 1 to 3 were prepared from glass-epoxy laminate. During the delamination introduction process, all trapezoidal artificial delamination areas of the specimens were filled with: (1) polyvinyl alcohol with a thin copper wire, or (2) thin polyethylene film, or (3) rectangular teflon insert. Specimens 4 to 7 were prepared from carbon-epoxy laminate. Specimen 4 was pure, without artificial delamination, while specimens 5 to 7 had delamination areas filled with polyvinyl alcohol, thin polyethylene film, and rectangular teflon insert, respectively, like in case of the glass-epoxy specimens.

Six specimens shown in Fig 3 were used in the tests.

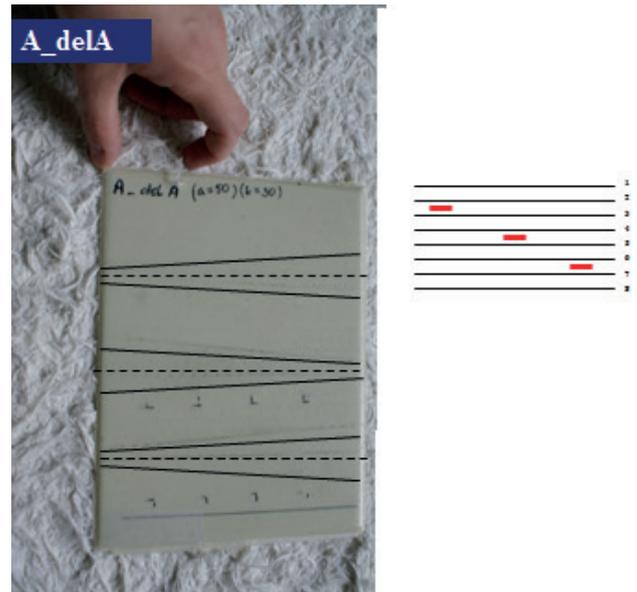
Fig. 4. View of Specimen 1, made of glass-epoxy laminate. To generate delamination, the places marked as trapeziums were covered with polyvinyl alcohol between layers 2 and 3, 4 and 5, and 6 and 7 in the production process

During the production process, a copper wire was introduced to the places covered with polyvinyl alcohol to enable the generation of additional high-voltage discharge, and thus provoke the appearance of delamination being the object of further examination.

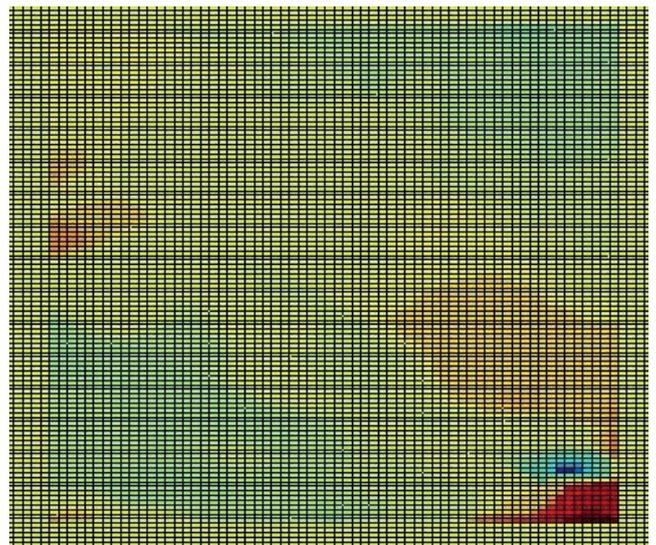
Fig. 5. Visualisation of Specimen 1, made of glass-epoxy laminate with trapeziums covered with polyvinyl alcohol to provoke local adhesion loss and further delamination between layers 2 and 3, 4 and 5, and 6 and 7

The analysis of the test results having the form of the recorded images clearly detects the delaminations. The method of their detection is very effective, fast, and efficient. The recorded images have made a basis for evaluating the efficiency of particular delamination introduction methods. Covering Specimen 1, made of glass-epoxy laminate, (Fig. 4), with polyvinyl alcohol did not result in local adhesion loss (Fig. 5), and the only visualised damage was caused by removing the specimen from the mould.

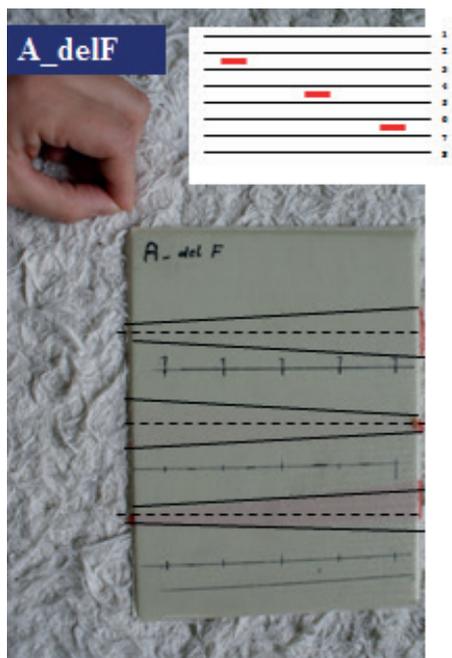
Fig. 6. View of Specimen 2, made of glass-epoxy laminate with places of introduction of trapezium shaped polyethylene films between layers 2 and 3, 4 and 5, and 6 and 7

Three thin trapezium shaped films were introduced to Specimen 2, made of glass-epoxy laminate, between layers 2 and 3, 4 and 5, and 6 and 7 (Fig. 6).

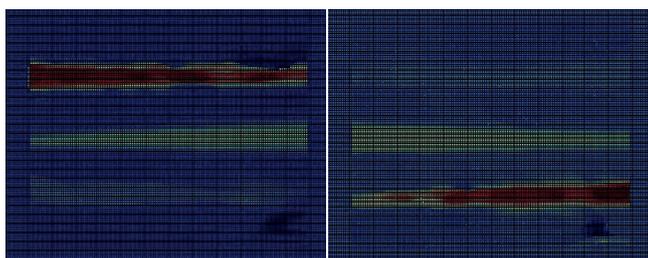
Fig. 7. Visualisation of delamination of Specimen 2. Internal delaminations obtained when the transducer was glued at the bottom left corner on the smooth side of the specimen and the rough surface was scanned (left), and when the transducer was glued at the bottom left corner on the rough side of the specimen and the smooth surface was scanned (right)

On the left-hand side, Fig. 7 shows the visualisation of internal delaminations obtained by exciting the Lamba waves with the aid of the trasducer glued at the bottom left corner on the smooth surface of the specimen and scanning the rough surface, while the visualisation shown on the right-hand side was obtained in the opposite situation, i.e. when the trasducer was moved to the bottom left corner of the rough surface and the smooth surface of the specimen was scanned.

Figure 7 shows clear patterns of internal delaminations, the used colour palette illustrates the depth of delamination position. The patterns on the left-hand and right-hand sides are similar to each other. The right-hand pattern can be obtained after transforming the left-hand pattern by rotation by 180° with respect to the bottom right corner, which reflects the arrangement of the delaminations purposely introduced to the structure of the laminate. The performed examination indicates that the efficiency of generating artificial internal

delaminations by introducing the films during the production process is high; the images of the introduced films are almost identical in both cases. We can also conclude that the side on which the trasducer is glued and the side along which the specimen is scanned do not affect the results of the examination. Further research is to be performed to separate the trasducer position/surface smoothness relation, from that between the surface smoothness and the scanned pattern.

Figure 7 shows visualisation of elamination of Specimen 2.

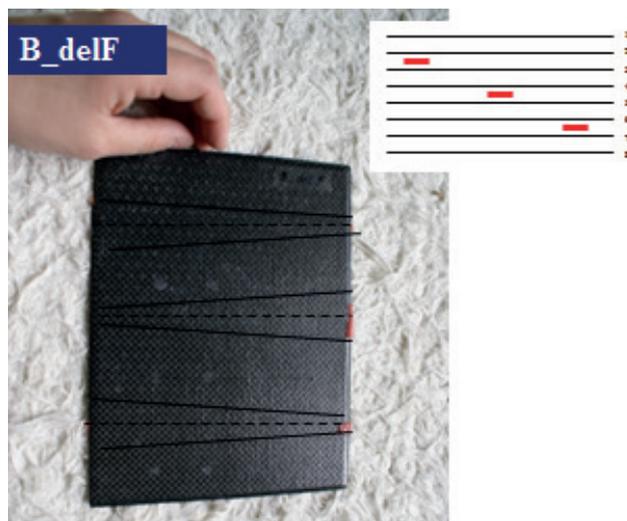
Fig. 8. Carbon-epoxy laminate with

However, unlike the test with the glass-epoxy laminate, here scanning Specimen 6 (Fig. 8), made of carbon-epoxy laminate with thin film introduced to generate delamination, has revealed some effect of trasducer position and scanned surface smoothness on the recorded results. More precise evaluation of this effect requires additional tests. The visualisation patterns on the left-hand and right-hand sides clearly differ between each other, by colours attributed to particular delaminations and depths of their positions in the laminate, rather than by delamination shapes themselves.

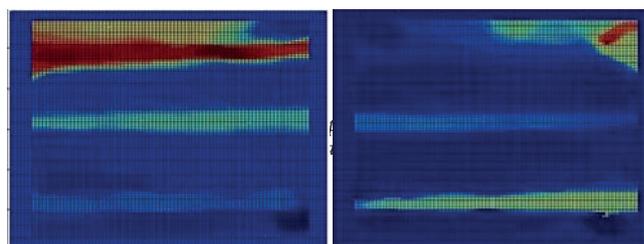
Fig. 9. Visualisation of delamination of Specimen 6 made of carbon-epoxy laminate with artificial delamination generated by introducing a thin film. The trasducer was glued on the smooth side of the specimen and the rough side was scanned (left), and trasducer was glued on the rough side of the specimen and the smooth side was scanned (right).

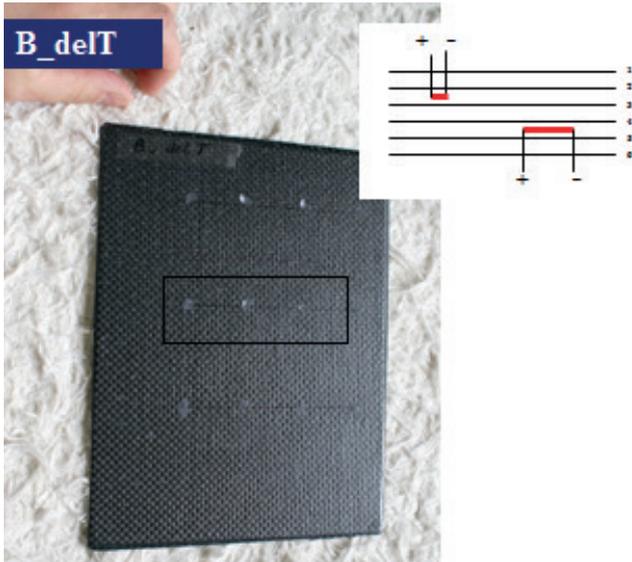
Fig. 10. Specimen 7, made of carbon-epoxy laminate, with (1) rectangular teflon insert and copper wire, and (2) a separate copper wire introduced during the production process

For Specimen 7 (Fig. 3 and Table 1), made of carbon-epoxy laminate, a rectangular teflon insert with a copper wire was introduced into it, and separately a cooper wire alone, see Fig. 10. If no delamination had been recorded, the specimen was planned to be exposed to high-voltage discharge.

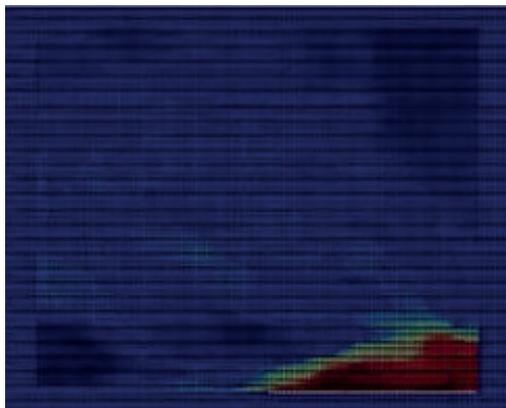
The visualisation did not detect the presence of delamination (Fig. 11). Here, the introduction of teflon turned out ineffective, as far as the goals of the reported research were concerned.

Fig. 11. Visualisation of Specimen 7 made of carbon-epoxy laminate, with locally introduced teflon insert. The transducer was glued on the smooth surface of the specimen and the rough surface was scanned
