## SHORT-TERM AND LONG-TERM VARIABILITY OF ANTENNA POSITION DUE TO THERMAL BENDING OF PILLAR MONUMENT AT PERMANENT GNSS STATION

Lubomira Gerhatova, Jan Hefty, Peter Spanik

Department of Theoretical Geodesy  
Faculty of Civil Engineering  
Slovak University of Technology in Bratislava

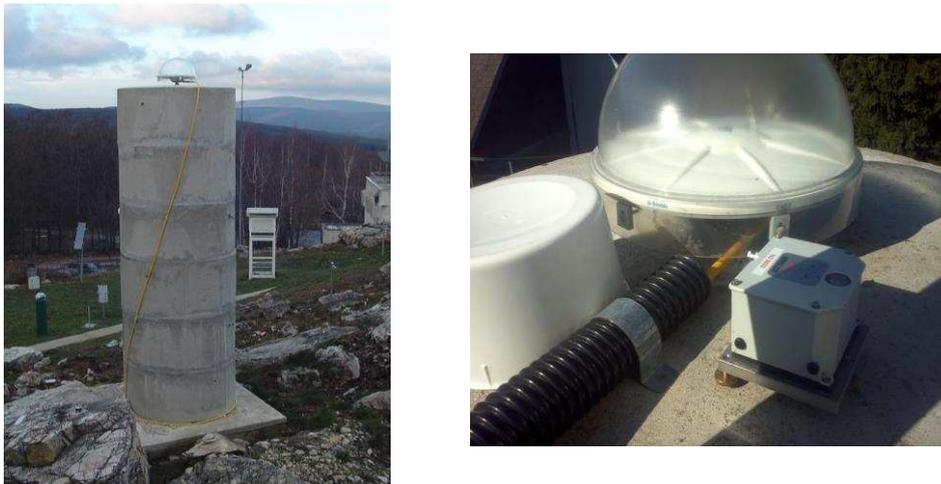
**Fig. 1.** Pillar monument at station Modra-Piesok MOP2 (left) and detail with GNSS antenna and inclination sensor (right).

Permanent station MOP2 is situated in areal of Astronomic-geophysical observatory of Comenius University in Bratislava, Slovakia at Modra-Piesok locality in Little Carpathian Mountains approximately 530 meters above sea level (Fig. 1). The monument of MOP2 was built in 2007 as massive concrete pillar with height of 3 meters and diameter of 1 meter. Monument stands on concrete basement with dimension  $1.5\text{ m} \times 1.5\text{ m} \times 0.5\text{ m}$  which is anchored to bedrock. Pillar's body is made of circular shape concrete preforms filled up by concrete. At the top there is steel console joined to concrete part. GNSS antenna is mounted on steel rod screwed to console. Nivel220 sensor was placed next to console on the concrete surface during the experiment.

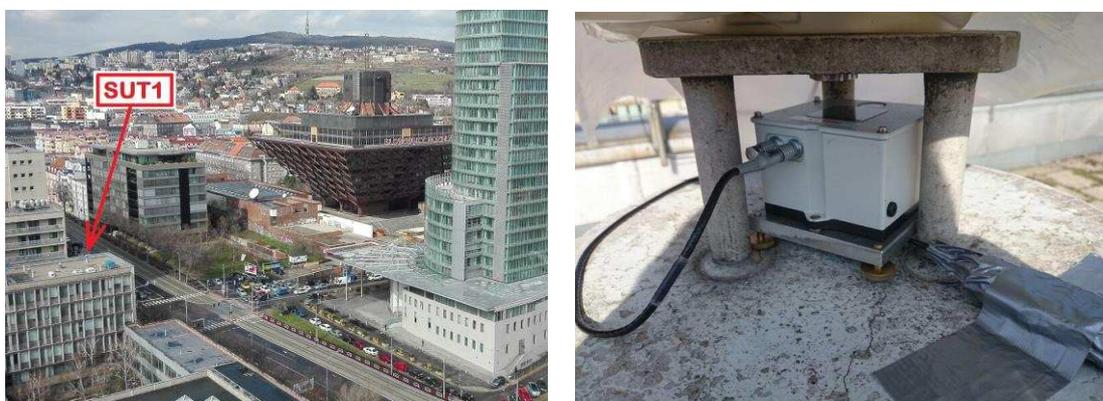
**Fig. 2.** Pillar monument of GNSS station SUT1 situated on a top of 6-floor building of Faculty of Civil Engineering in centre of Bratislava.

Permanent station SUT1 is located at the roof of block A building at Faculty of Civil Engineering, Slovak University of Technology in Bratislava, Slovakia (Fig. 2). It is made as reinforced concrete pillar with height 1.21 m and diameter 0.40 m. In top part of pillar there is a steel console with screwed GNSS antenna. Nivel220 sensor is placed under the console.

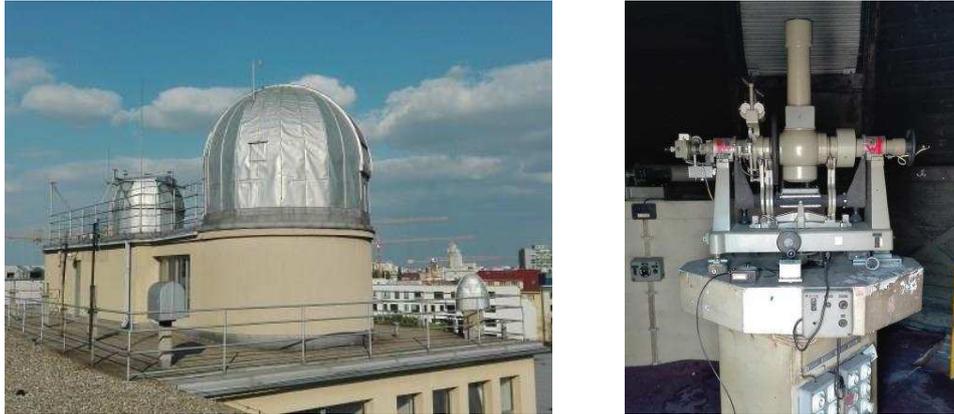
**Fig. 3.** Pillar for geodetic astronomy observations situated on top of 5-floor historical building of SUT in Bratislava. Inclination sensor is on the pillar in front of the Transit Instrument.

The third place we used for our experiment is the massive pillar for geodetic astronomy observations (Fig. 3) situated in observatory on top of 5-floor historical building of Slovak University of Technology in centre of Bratislava (in following text

referenced as OBS). This building with observatory was built in 1946. Massive rectangular shaped concrete pillar with dimension  $0.75\text{ m} \times 0.50\text{ m}$  is joined with the building structure. Inclination sensor is placed on the pillar's top concrete surface in front of the old transit instrument. This pillar is covered by dome and is not directly suitable for GNSS observations; however it can serve for studies of tilt variation of monument at the top of building.

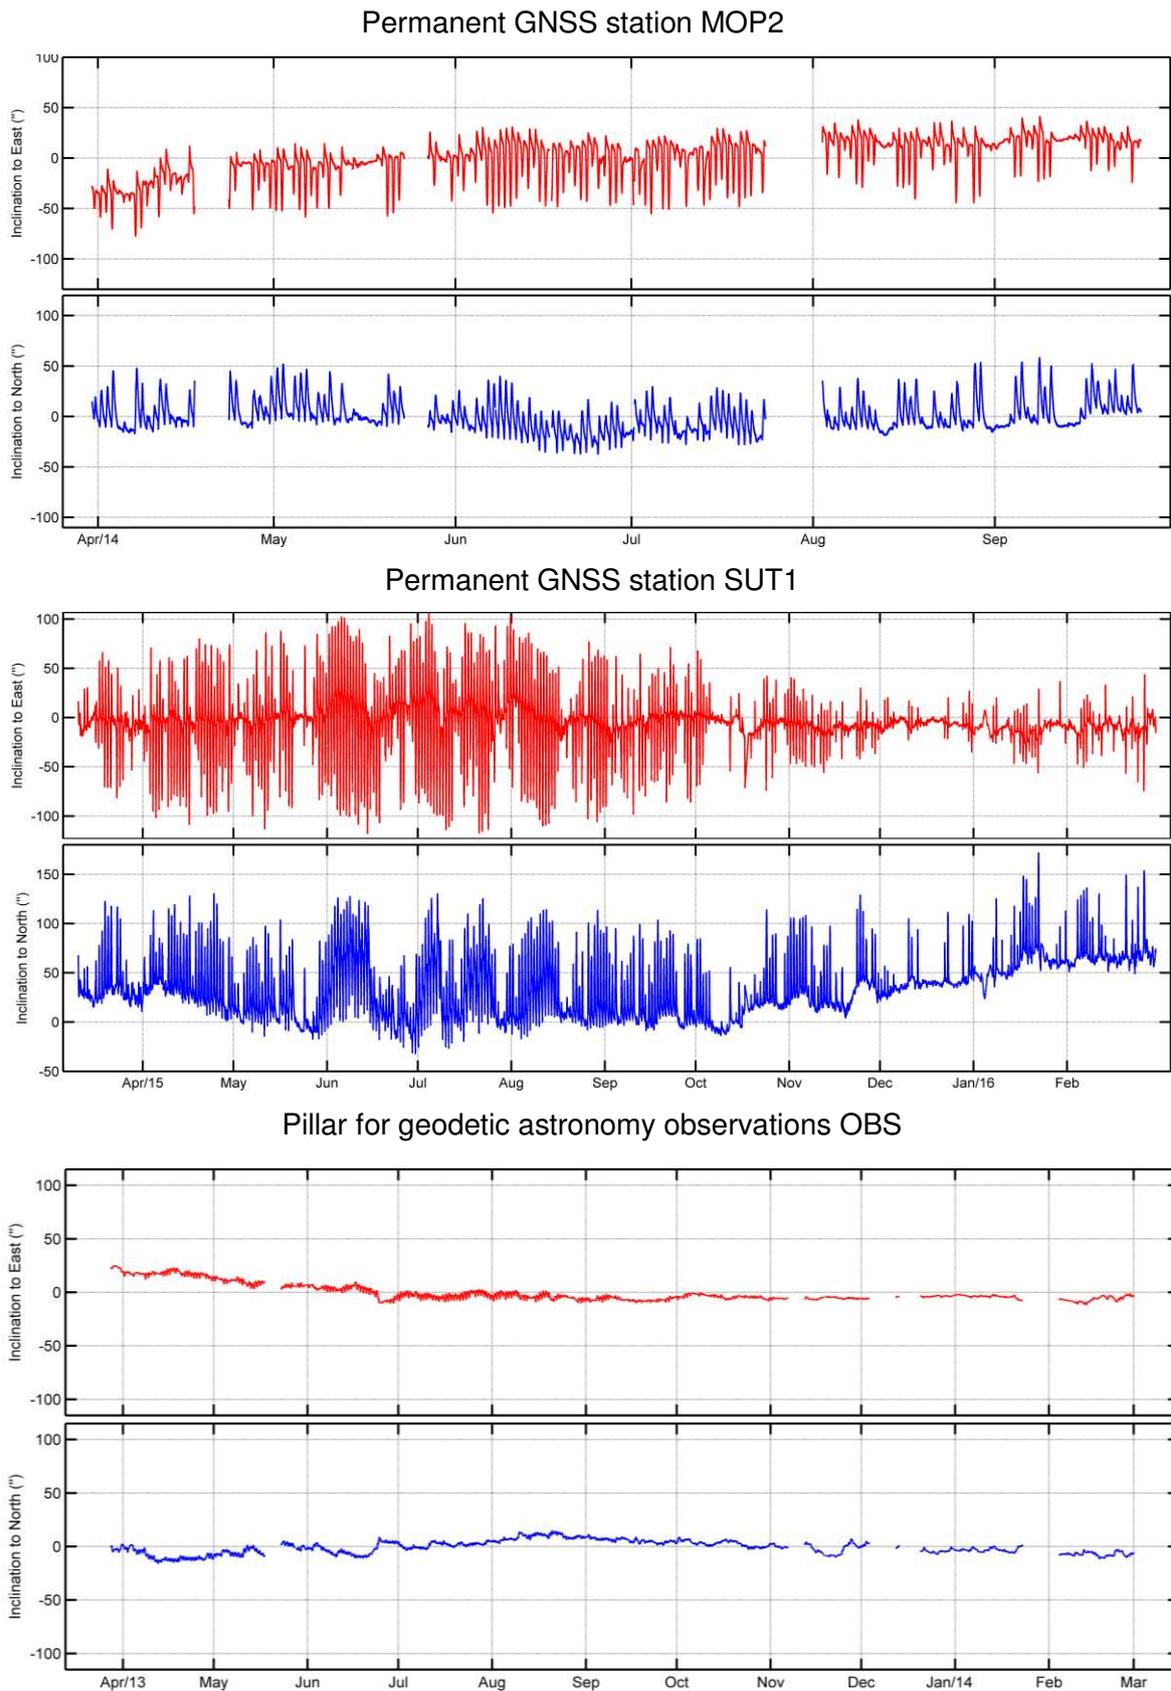
**Fig. 4.** Long-term time series of inclination observations. The scales for the inclination constituents are identical for all pillars.

The time series of inclination in east-west and north-south constituents for the three pillars mentioned are in plotted in Fig.4. It worth to mention that the zero value for all the series was defined according the procedure described below.

It is evident that the inclination long-term and short-term behaviour is significantly different at each of the three analysed pillars. SUT1 has significantly changing daily variation depending on the season of the year. There is approximately twice times higher variation during the summer than through the winter. At MOP2 we cannot reliably evaluate seasonal variation due too short time series data. In case of OBS pillar we can clearly see the most stable long-term and short-term stability. We consider it is caused by dome coverage and then no direct impacts of weather conditions are possible. In long-term investigations we should point out to effect of long-term stability of precise inclination sensor, which would be crucial for this purpose.

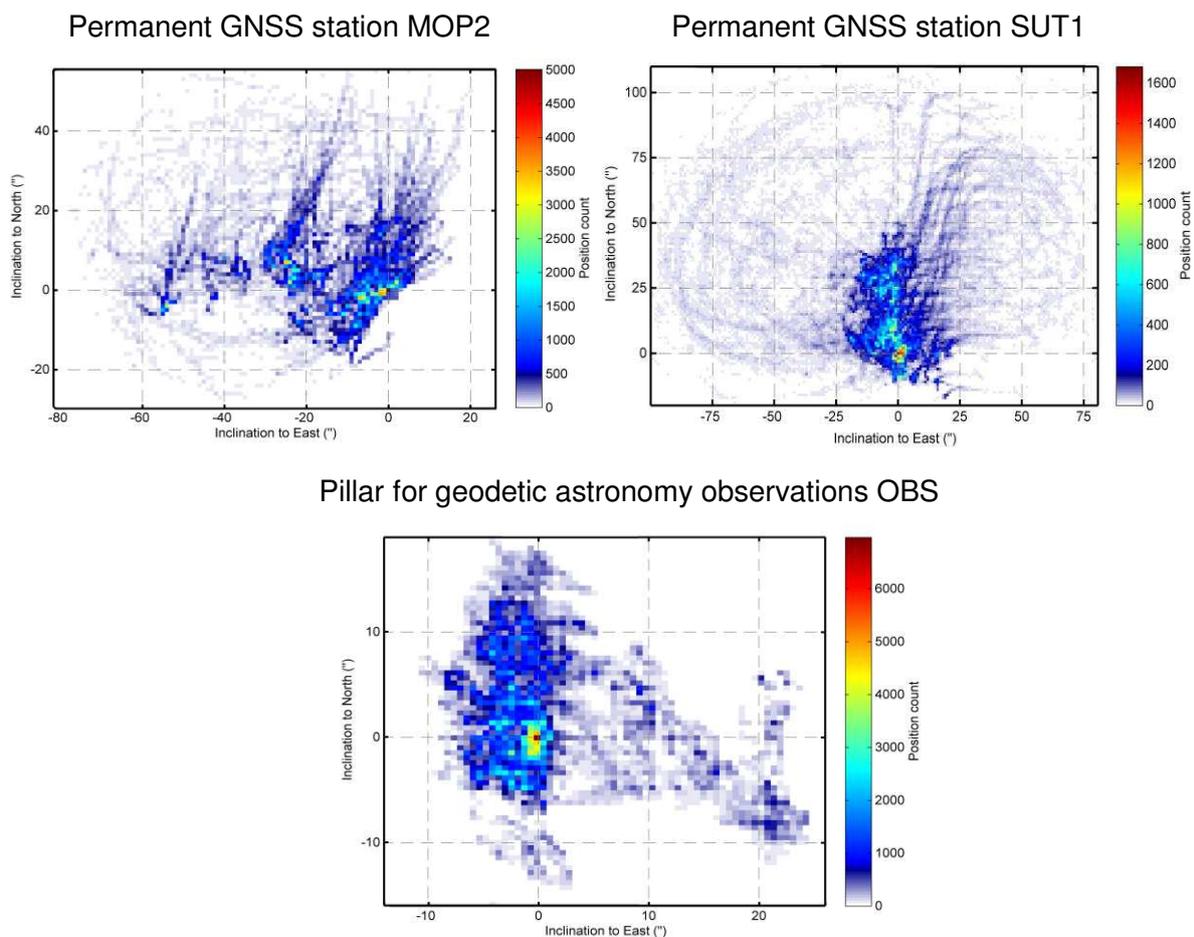
**Fig. 5.** Histograms of long-term inclination measurements with raw sampling intervals at three different pillars.

To estimate reference point of each set of measurements two-dimensional histograms were used (Fig. 5). We assume that measurements with the highest probability have also the highest count of occurrences in bin. For every histogram we determined bin with the most count of occurrences which represent reference point. Subsequently the interpolated measurements were reduced by this reference point's values.

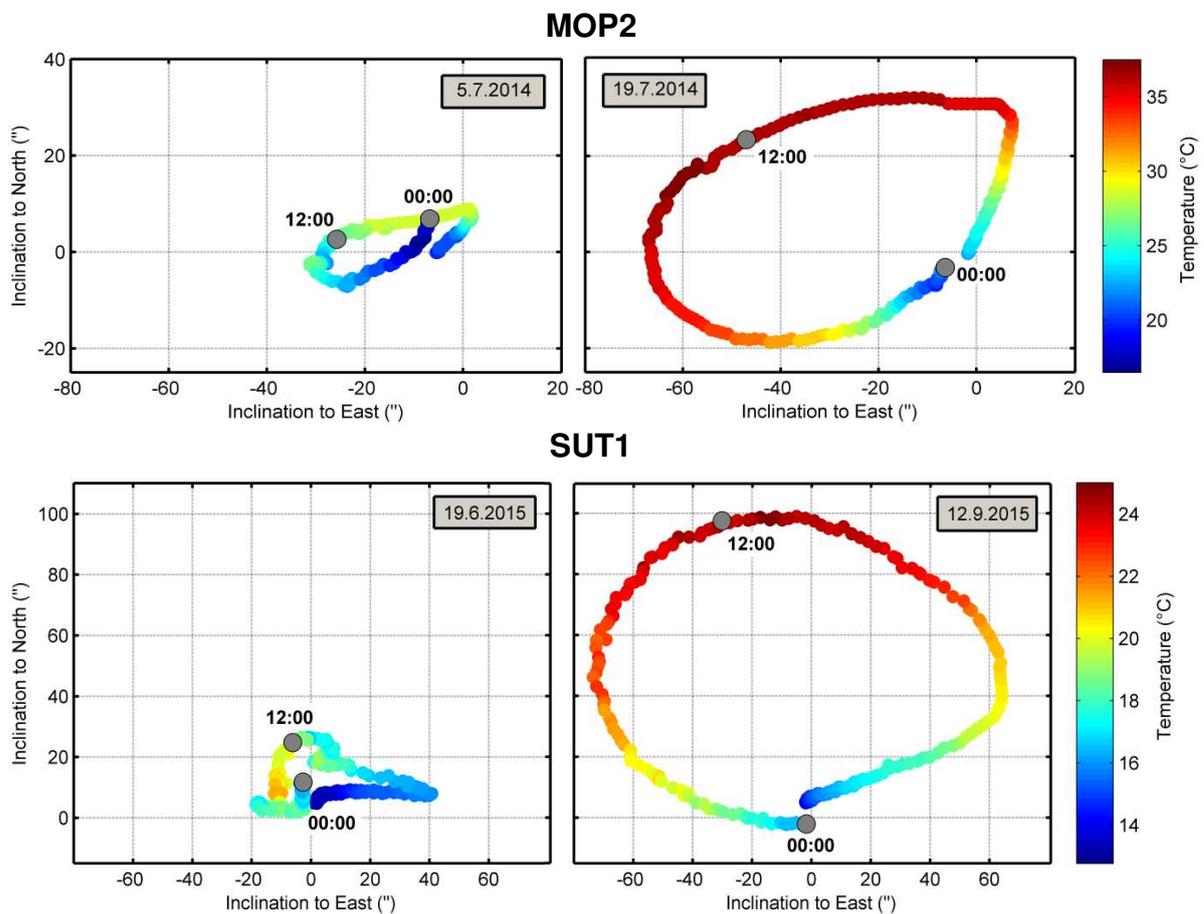
**Fig. 6.** Diurnal cycle of inclination observed at MOP2 and SUT1 in various temperature daily change (temperature course is represented by colours). On the left side are measurements during cloudy days and on the right side the days with all-day sunshine.

In case of clear cloudless sunny weather with high daily temperature change the pillar performed regular elliptical movement (Fig. 6, right). With vague time delay after sunrise pillar starts to tilt from the sun. In some cases it came back to start position during night, in some cases not.

In case of cloudy, possibly rainy weather without sunshine with small diurnal temperature variability there is just small, nearly none pillar motion (Fig. 6, left).

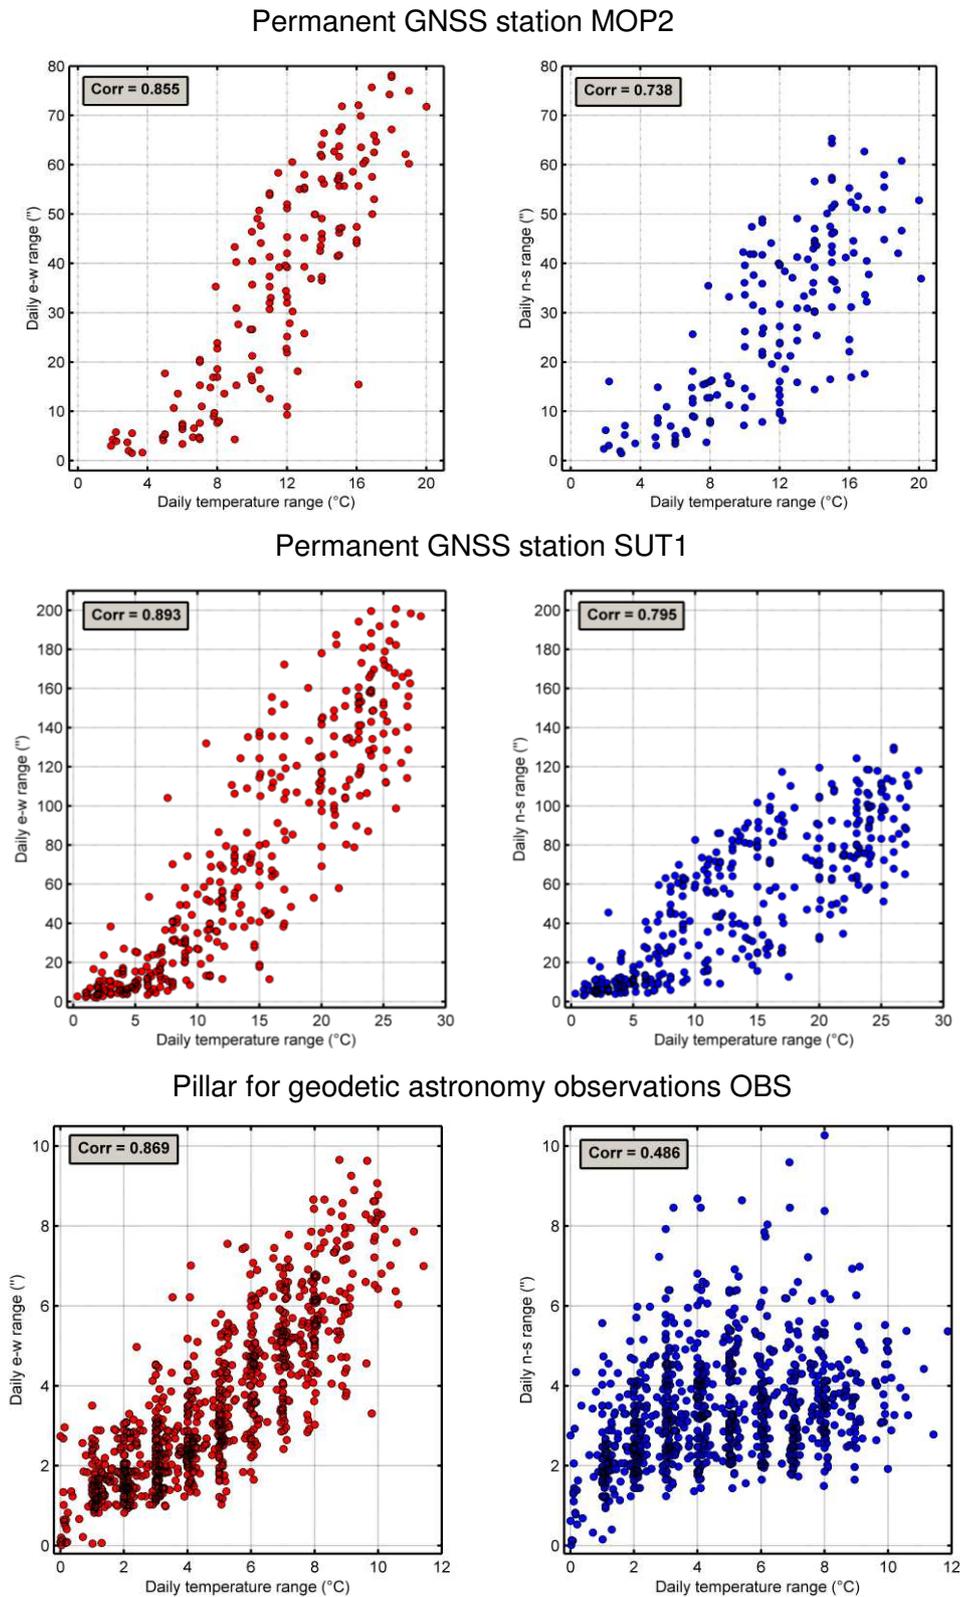
**Fig. 7.** Daily temperature range versus inclination ranges (east-west and north-south) observed at three various pillars.

MOP2: daily variability of temperature ranges from 2 to 20°C (experiment was made during spring and summer). To these values belong inclination values from 0" to 80" in east-west direction and from 0" to 65" in north-south direction. Magnitude of this inclinations concerns with pillar's dimension (diameter of 1 m).

SUT1: daily variability of temperature ranges from 0 to 28°C (experiment was made throughout the year). To these ranges belong values from 0" to 200" in east-west direction and from 0" to 130" in north-south direction. Larger inclination's ranges are linked to smaller pillar's dimension (diameter 0.40 m), but especially with the fact that the pillar is situated on the top of building. We assume that in long-term view also the building itself make a movement in dependence of temperature changes due to changing of seasons throughout the year. This movement is partially part of measured inclinations. In both cases high value of correlation coefficient was computed, specifically 0.73 – 0.89, what represent strong correlation dependence.

OBS: to validate our assumptions we show results from pillar OBS where daily variability throughout whole year did not get over 12°C and inclinations in both directions did not get over 10". Correlation coefficient has values 0.87 (east-west direction) and 0.49 (north-south direction).

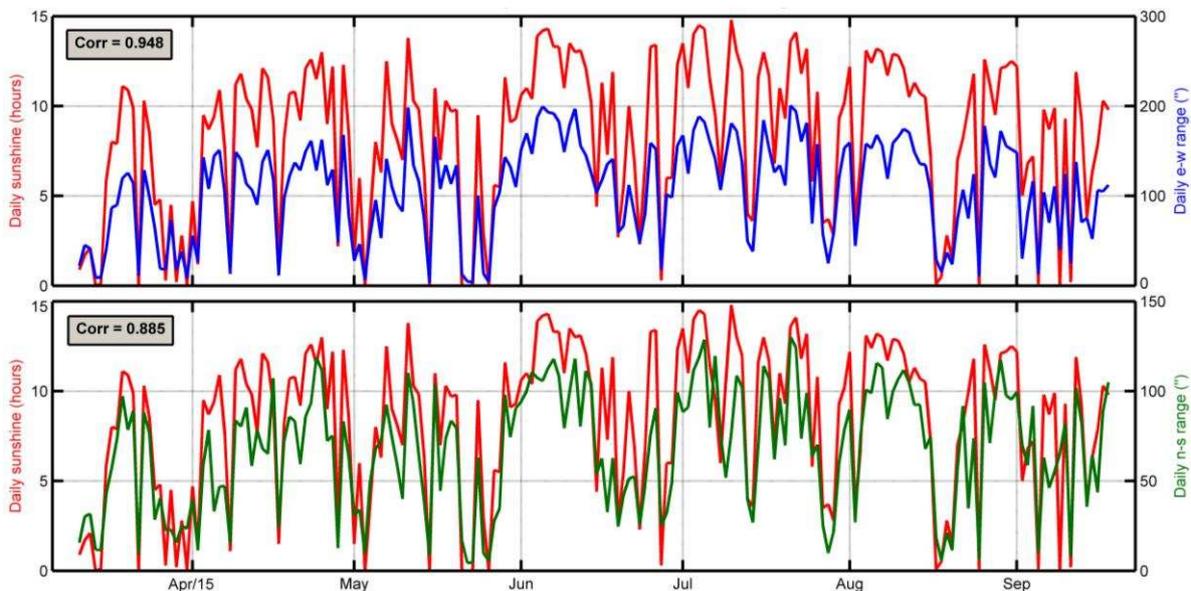
**Fig. 8.** Time series of daily inclination ranges in east-west (in blue) and north-south (in green) constituents observed at SUT1 pillar, and the duration of daily sunshine (in red).

Similar results we achieve also with analysis of inclination's ranges and daily sunshine hours during day (Fig. 8). Used data are valid for Bratislava airport, approximately 7.5 km from SUT1. Value of sunshine hours during the day is just single number and we cannot perform in-depth analysis of daily sections.

Correlation between daily inclination's range and sunshine hours is strong in case of stable sunny or cloudy weather throught the day, in case of varying weather the correlation is low.
